L1358070001 – Montgomery
Eagle Zinc Company
ILD 930606941
SF/HRS

**CERCLA
EXPANDED SITE INSPECTION ADDENDUM REPORT**

Eagle Zinc Company

September 1, 2005

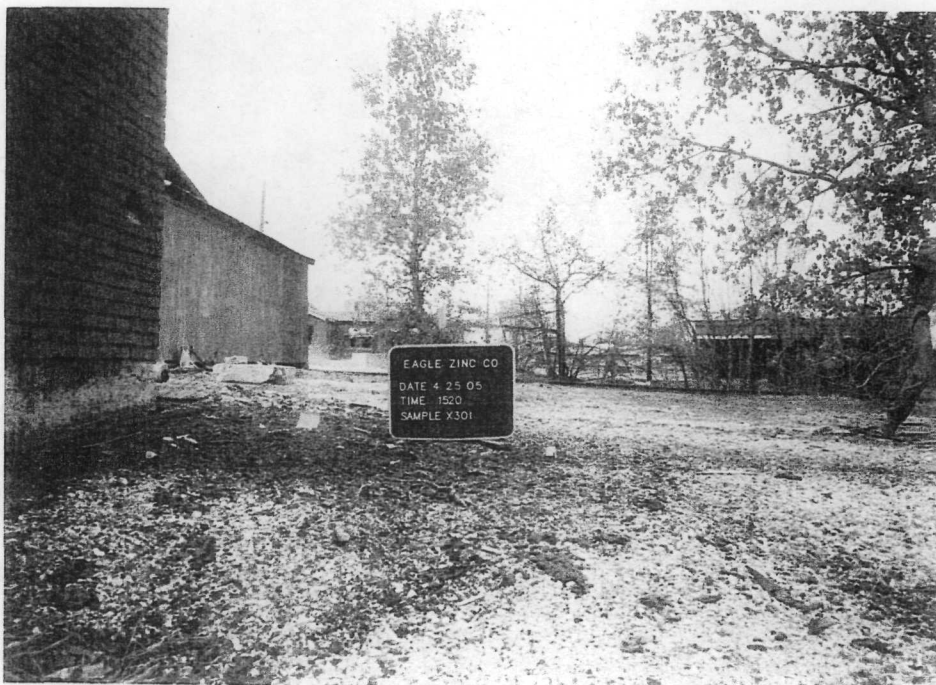
DATE: 4/25/05
TIME: 15:20
PHOTOGRAPH TAKEN BY: R. CASPER
COMMENTS: Picture taken toward: East.
Photo Number 2.
Sample X301. The sample consisted of a fine black material collected at a depth of 0 to 2 inches.

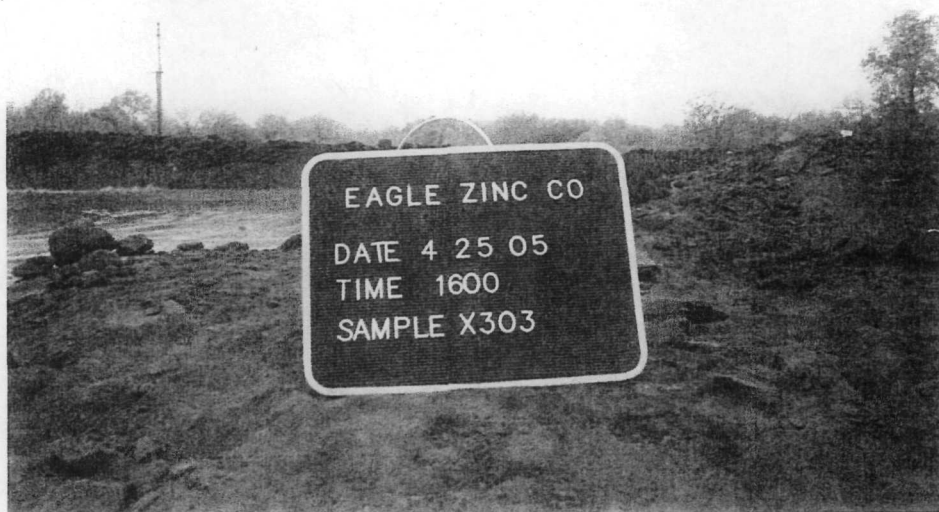
DATE: 4/25/05	SITE ILD#: 980606941	COUNTY: Montgomery
TIME: 16:00	SITE NAME: Eagle Zinc Co.	
PHOTOGRAPH TAKEN BY: R. Casper		
COMMENTS: Picture taken toward: West.		
Photo Number 5.		
Sample X303 was collected at the southwest area of the site from a slag material.

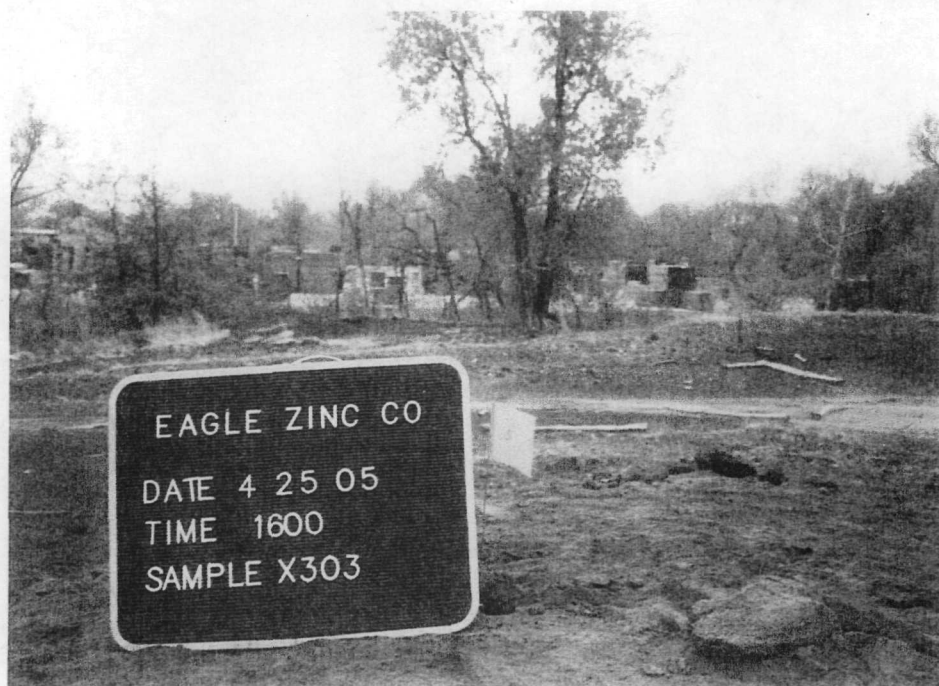
DATE: 4/25/05
TIME: 16:00
PHOTOGRAPH TAKEN BY: R. CASPER
COMMENTS: Picture taken toward: South.
Photo Number 6.
Sample X303. The sample consisted of a fine brownish gray material collected at a depth 0 to 2 inches.

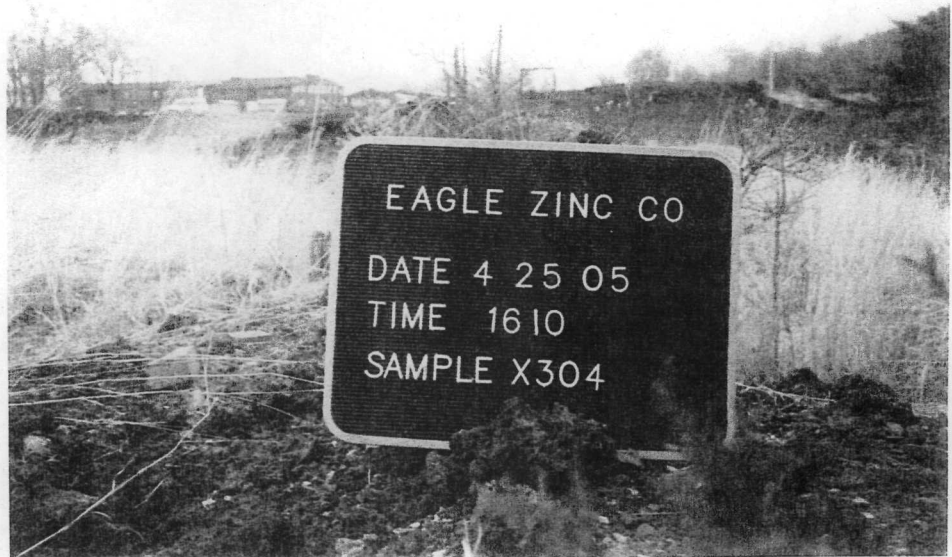
PHOTOGRAPH TAKEN BY: R. Casper
COMMENTS: Picture taken toward: East.
Photo Number 7.
Sample X304 was collected at the southwest area of the site from a slag pile.

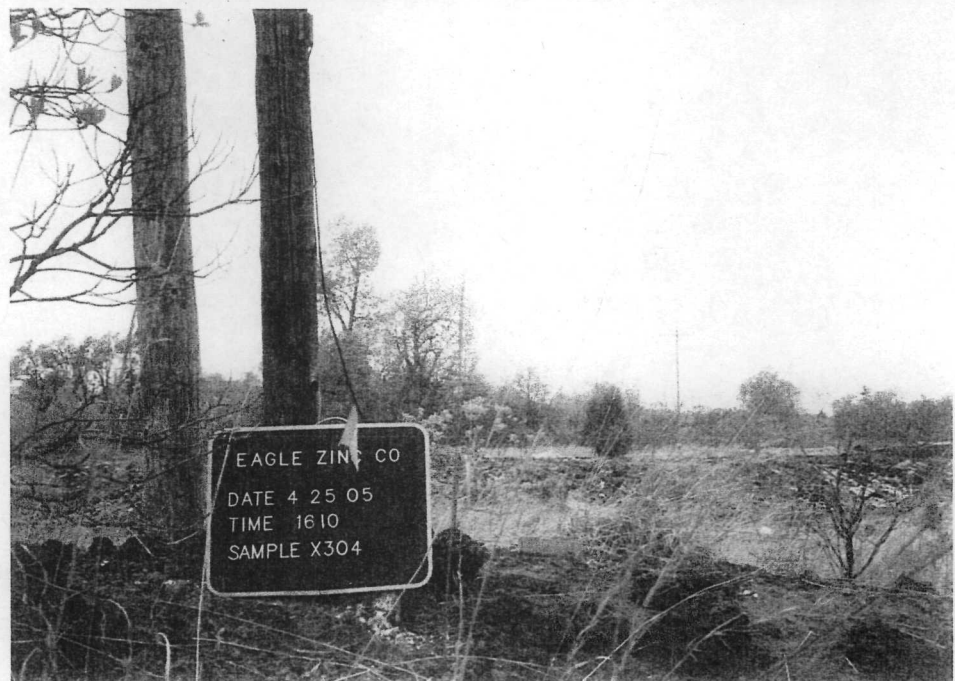
DATE: 4/25/05
TIME: 16:10
PHOTOGRAPH TAKEN BY: R. CASPER
COMMENTS: Picture taken toward: West.
Photo Number 8.
Sample X304. The sample consisted of an orange brown slag collected at a depth of 0 to 2 inches.

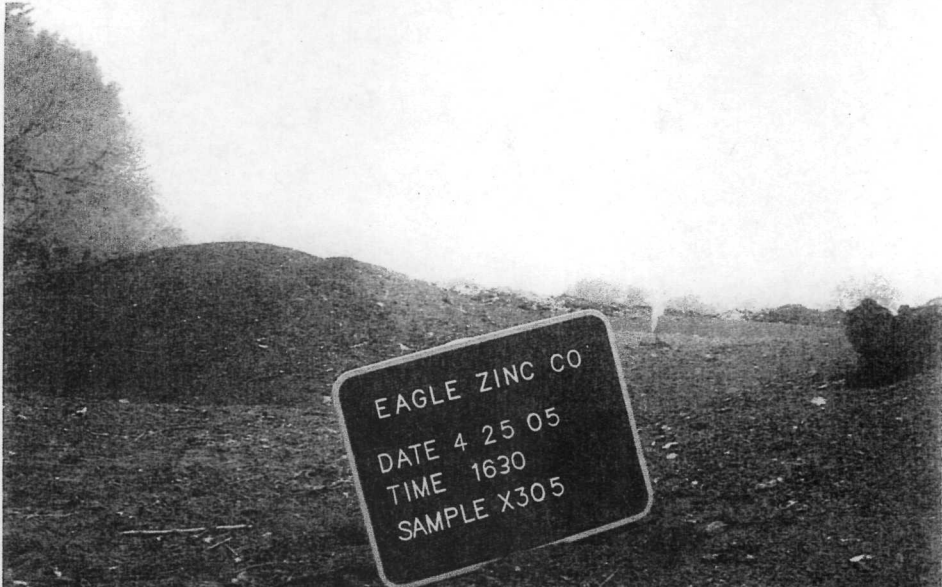
COMMENTS: Picture taken toward: West.		
Photo Number 9.		
Sample X305 was		
collected at the		
southwest area of the site from a slag pile.

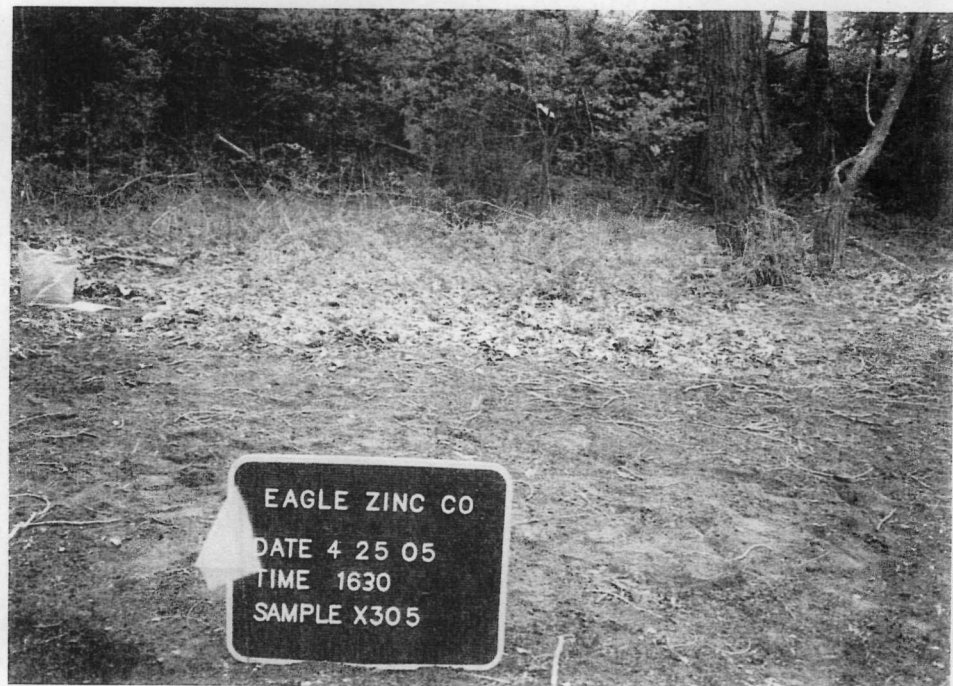
DATE: 4/25/05
TIME: 16:30
PHOTOGRAPH TAKEN BY: R. CASPER
COMMENTS: Picture taken toward: South.
Photo Number 10.
Sample X305. The sample consisted of a fine black- brown slag collect- ed at a depth of 0 to 2 inches.

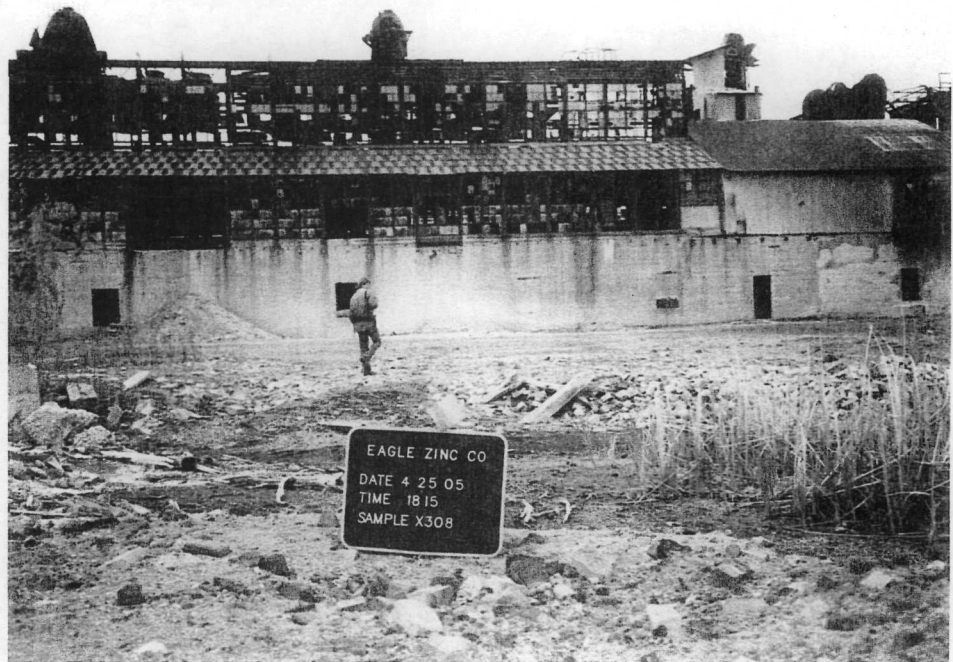
PHOTOGRAPH TAKEN BY: R. Casper
COMMENTS: Picture taken toward: east.
Photo Number 15.
Sample X308 was collected at the central area of the site from a slag pile.

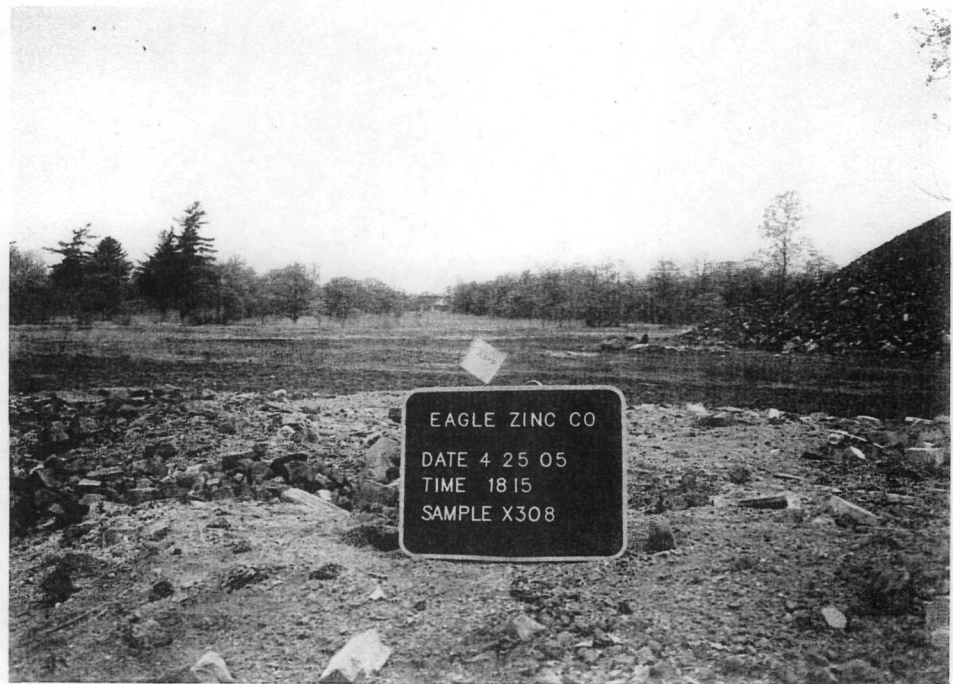
DATE: 4/25/05
TIME: 18:15
PHOTOGRAPH TAKEN BY: R. CASPER
COMMENTS: Picture taken toward: West.
Photo Number 16.
Sample X308. The sample consisted of light gray slag fines collected at a depth of 0 to ½ inches.

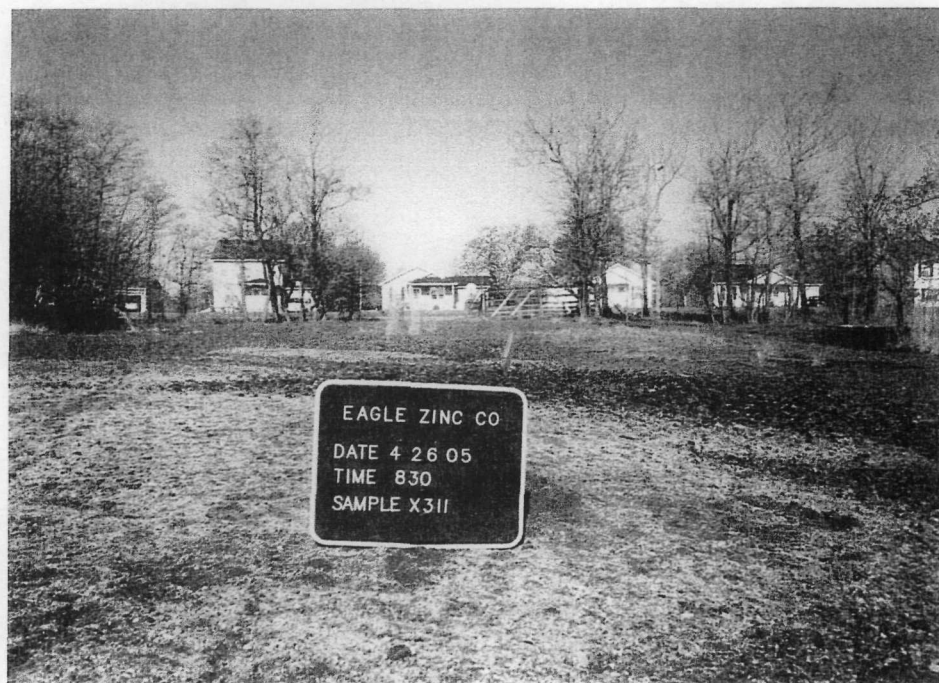
PHOTOGRAPH TAKEN BY: R. Casper
COMMENTS: Picture taken toward: West.
Photo Number 19.
Sample X311 was collected at the west area of the site. Houses lie across the street.

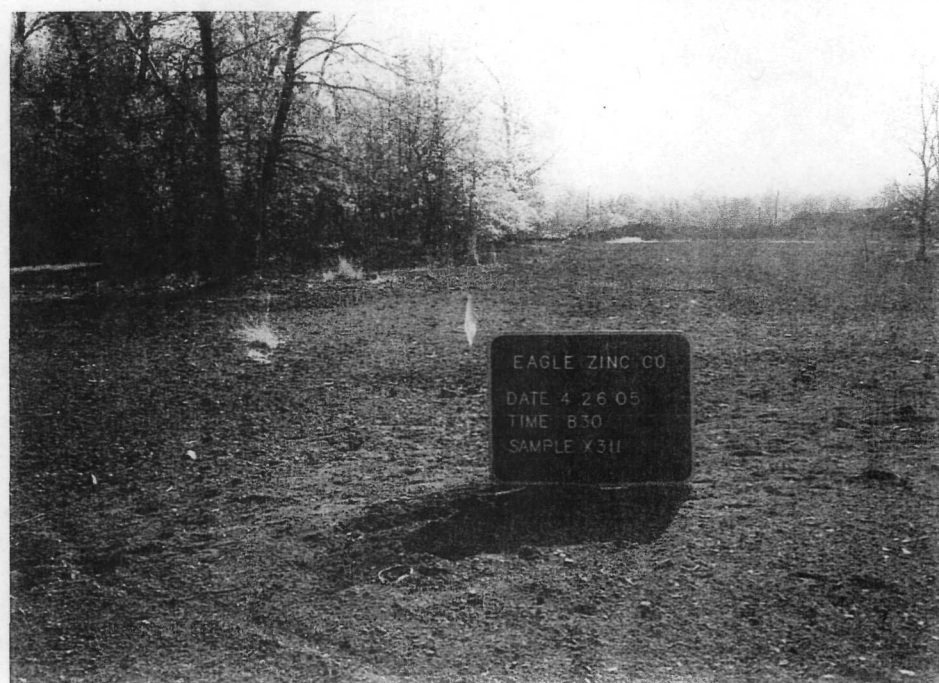
DATE: 4/26/05
TIME: 8:30
PHOTOGRAPH TAKEN BY: R. CASPER
COMMENTS: Picture taken toward: East.
Photo Number 20.
Sample X311. The sample consisted of a medium gray slag fines, from a depth of 0 to 1/2 inches.

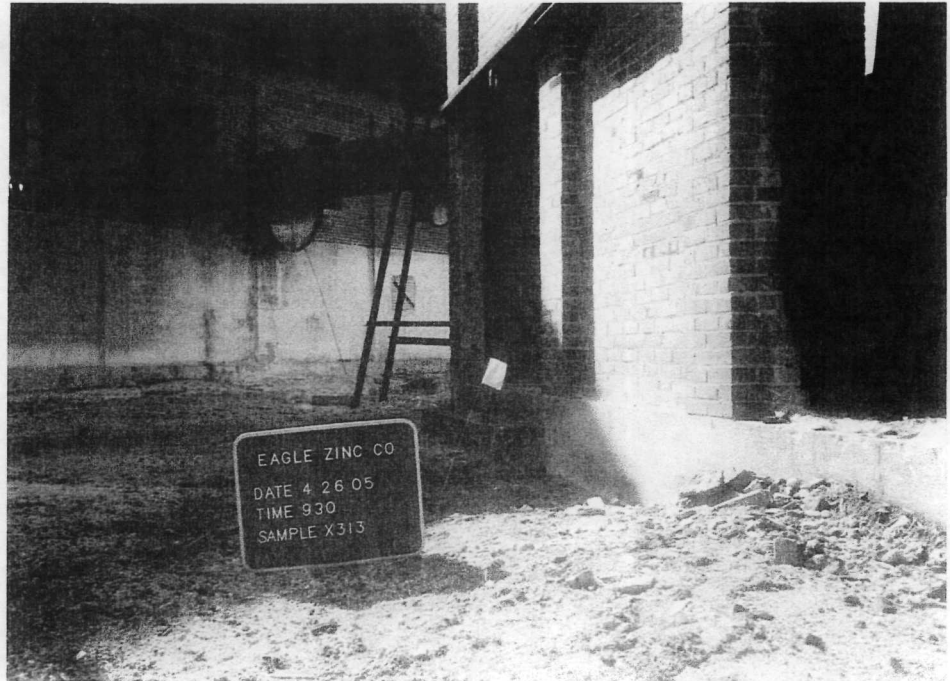
Photo Number 23.

Sample X313 was
collected at the
northeast area of
the site from a
slag pile.

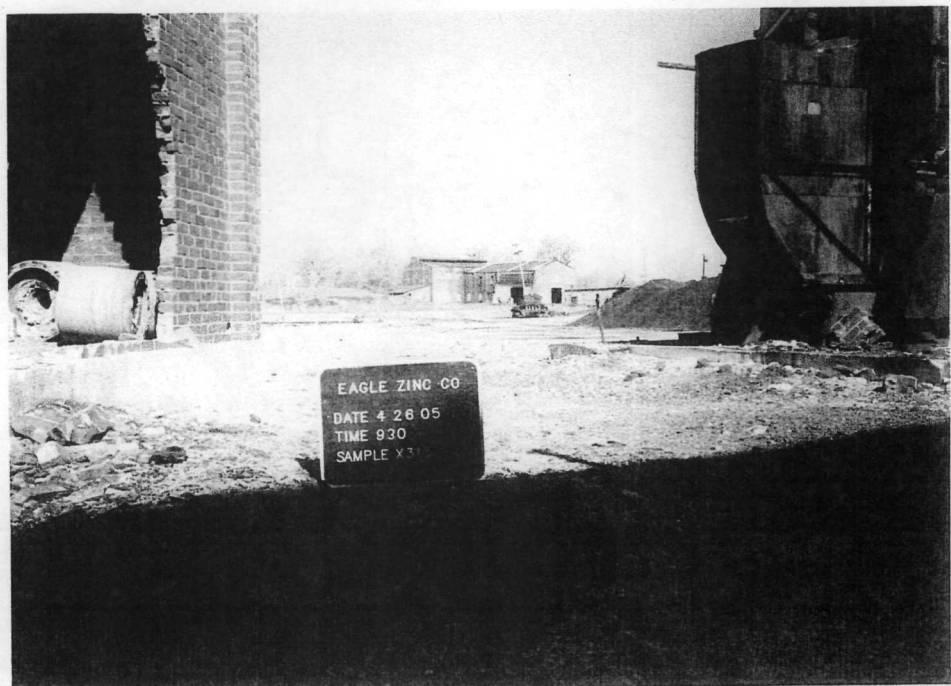
Sample X313. The
sample consisted
of a fine light
gray material with
white fragments.

Depth 0 to ½ inches

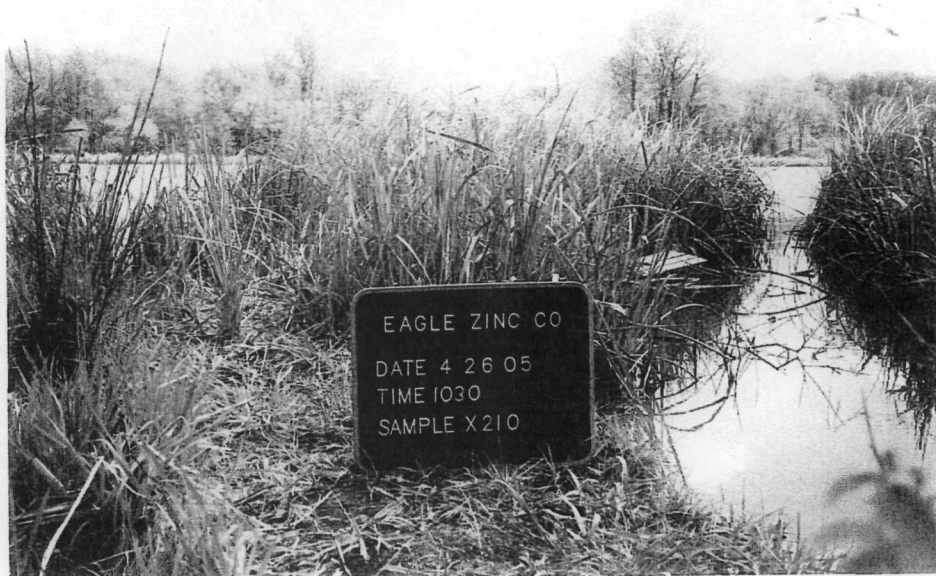
DATE: 4/26/05
TIME: 10:30
PHOTOGRAPH TAKEN BY: R. CASPER
COMMENTS: Picture taken toward: North.
Photo Number 26.
Sample X210 was consisted near the point where drainage from the site enters Lake Hillsboro.

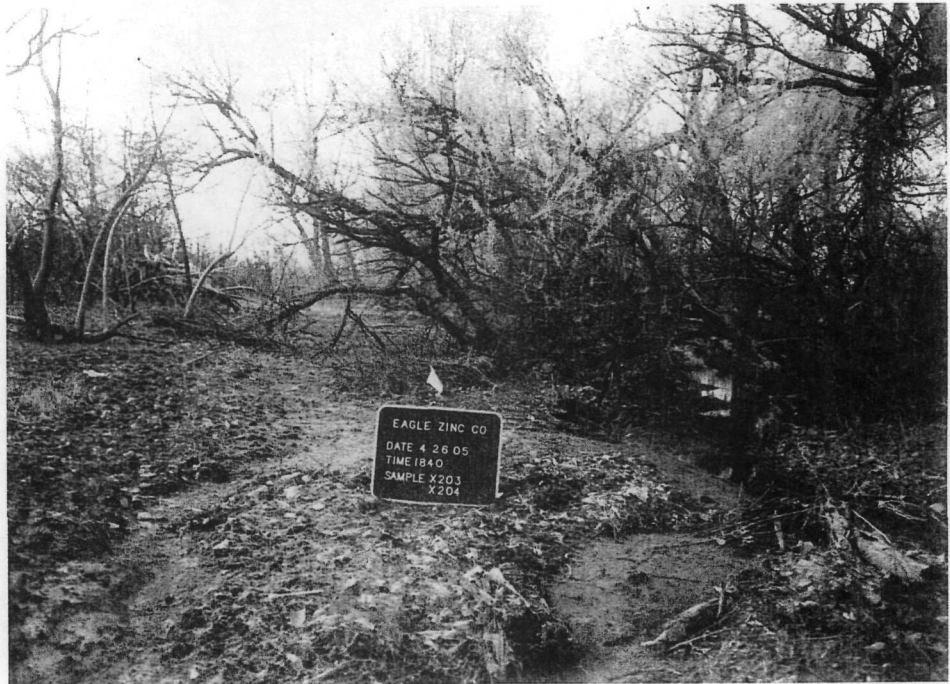
DATE: 4/26/05	SITE ILID#: 980606941	COUNTY: Montgomery
TIME: 18:40	SITE NAME: Eagle Zinc Co.	
PHOTOGRAPH TAKEN BY: R. Casper		
COMMENTS: Picture taken toward: West.		
Photo Number 39.		
Duplicate samples		
X203/X204 collected		
onsite west of		
Industrial Park		
Road.

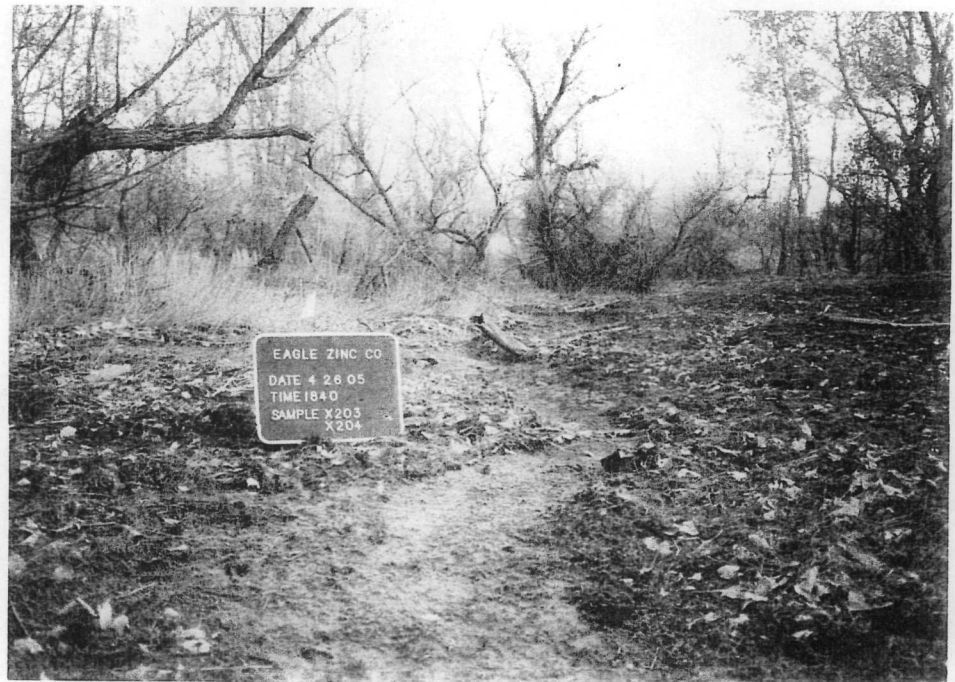
DATE: 4/27/05
TIME: 18:40
PHOTOGRAPH TAKEN BY: R. CASPER
COMMENTS: Picture taken toward: East.
Photo Number 40.
Samples X203/X204.
The samples
consisted of a
brown silty clay.
Collected 0 to 2
inches deep.

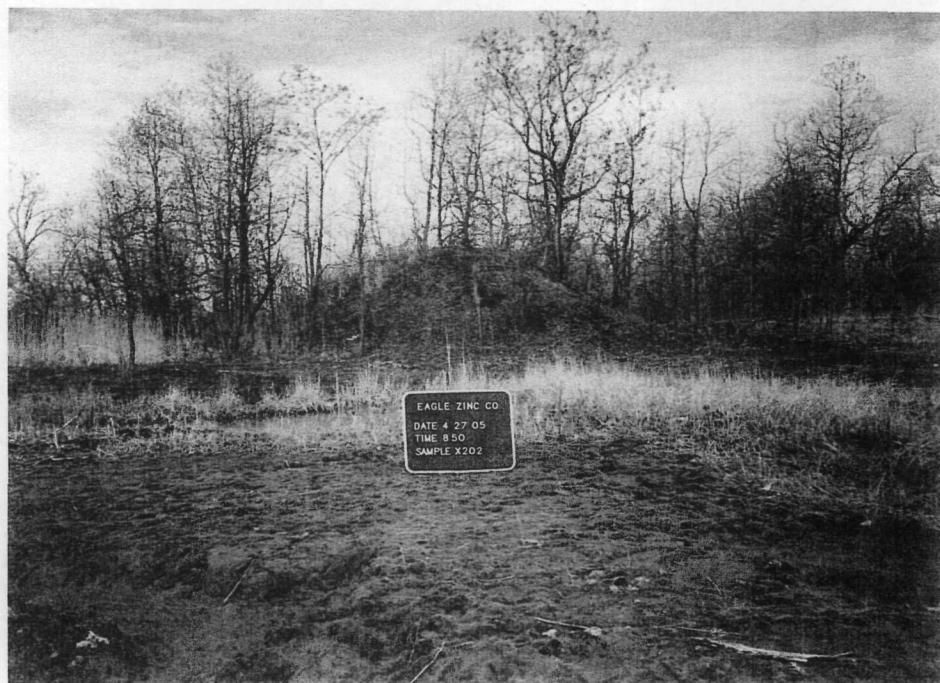
DATE: 4/27/05
TIME: 8:50
PHOTOGRAPH TAKEN BY: R. CASPER
COMMENTS: Picture taken toward: West.
Photo Number 42.
Sample X202. The sample consisted of a gray silty clay collected at a depth of 0 to 2 inches.

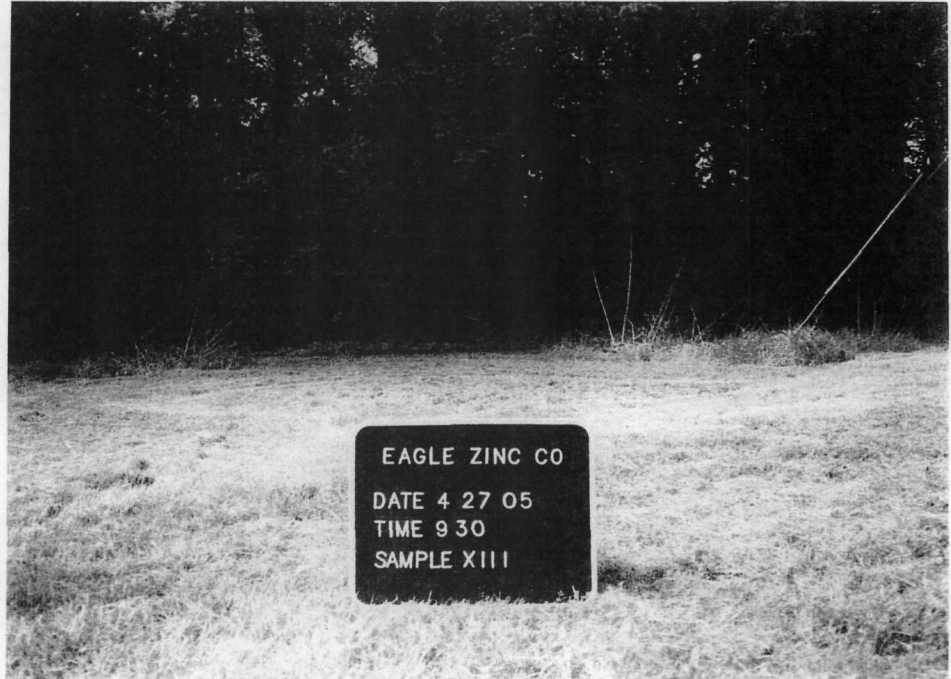
DATE: 4/27/05	SITE ILD#: 980606941	COUNTY: Montgomery
TIME: 9:30	SITE NAME: Eagle Zinc Co.	
PHOTOGRAPH TAKEN BY: R. Casper		
COMMENTS: Picture taken toward: South.		
Photo Number 43.		
Sample X111 was collected from a residential yard west of the site.

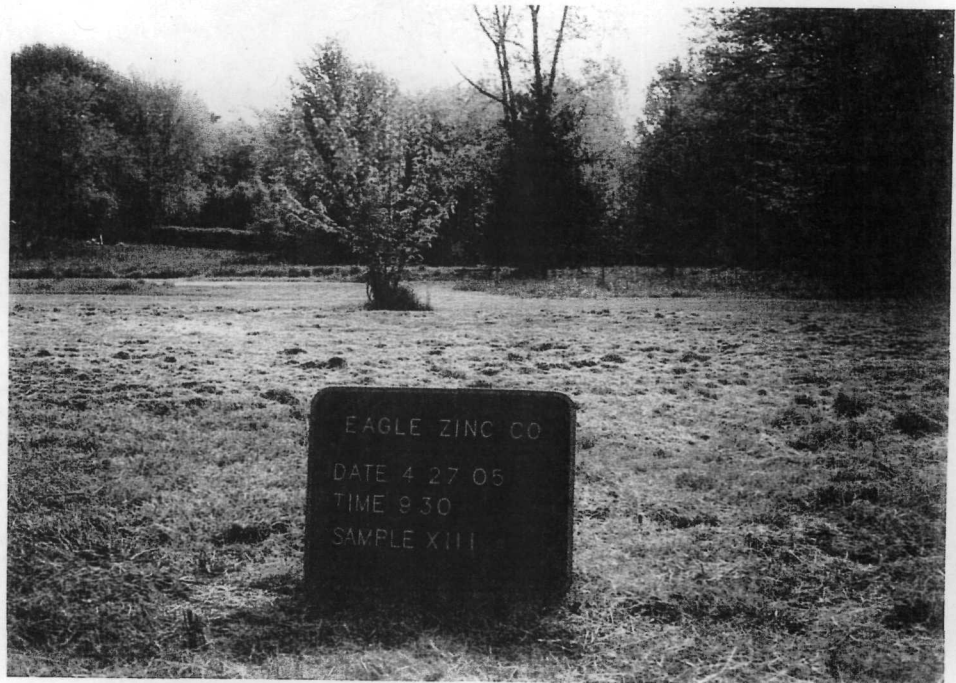
DATE: 4/27/05
TIME: 9:30
PHOTOGRAPH TAKEN BY: R. CASPER
COMMENTS: Picture taken toward: East.
Photo Number 44.
Sample X111. The sample consisted of a black silty loam collected at a depth of 0 to 1 inch.

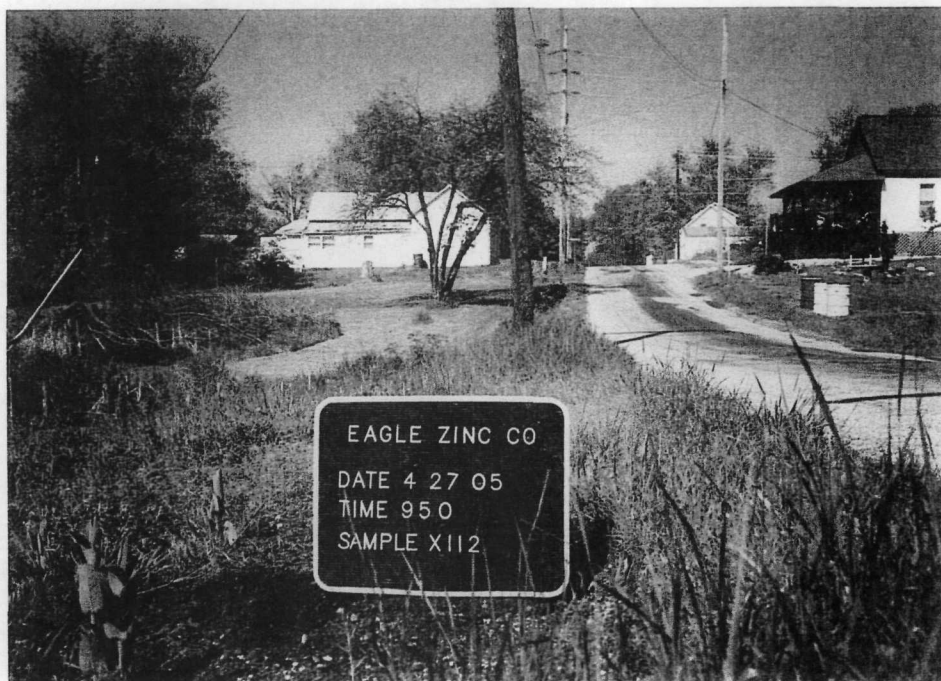
DATE: 4/27/05	SITE ILD#: 980606941	COUNTY: Montgomery
TIME: 9:50	SITE NAME: Eagle Zinc Co.	
PHOTOGRAPH TAKEN BY: R. Casper		
COMMENTS: Picture taken toward: South.		
Photo Number 45.		
Sample X112 was		
collected from a		
residential area		
west of the site.

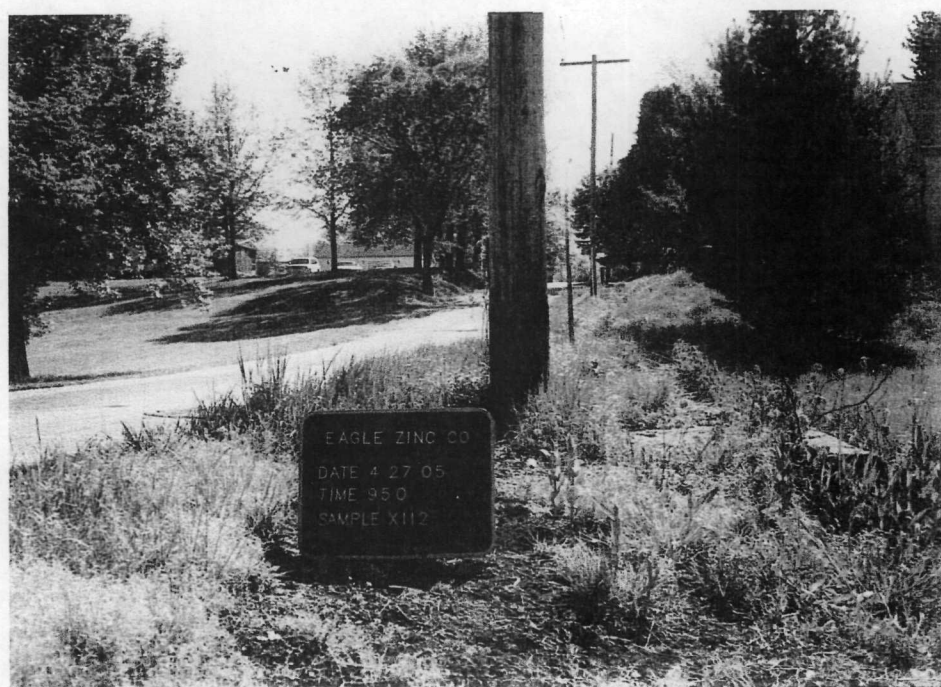
DATE: 4/27/05
TIME: 9:50
PHOTOGRAPH TAKEN BY: R. CASPER
COMMENTS: Picture taken toward: East.
Photo Number 46.
Sample X112. The
sample consisted
of reddish-brown
cinders and slag,
collected from a
depth of 0 to 2".

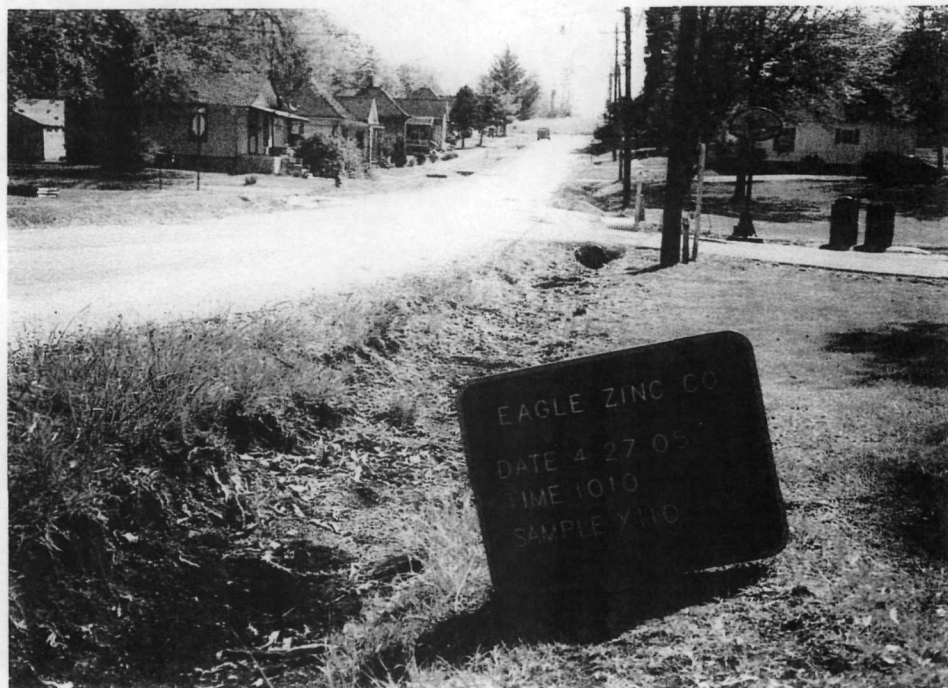
DATE: 4/27/05	SITE ILID#: 980606941	COUNTY: Montgomery
TIME: 10:10	SITE NAME: Eagle Zinc Co.	
PHOTOGRAPH TAKEN BY: R. Casper		
COMMENTS: Picture taken toward: East.		
Photo Number 47.		
Sample X110 was collected from a residential area west of the site.

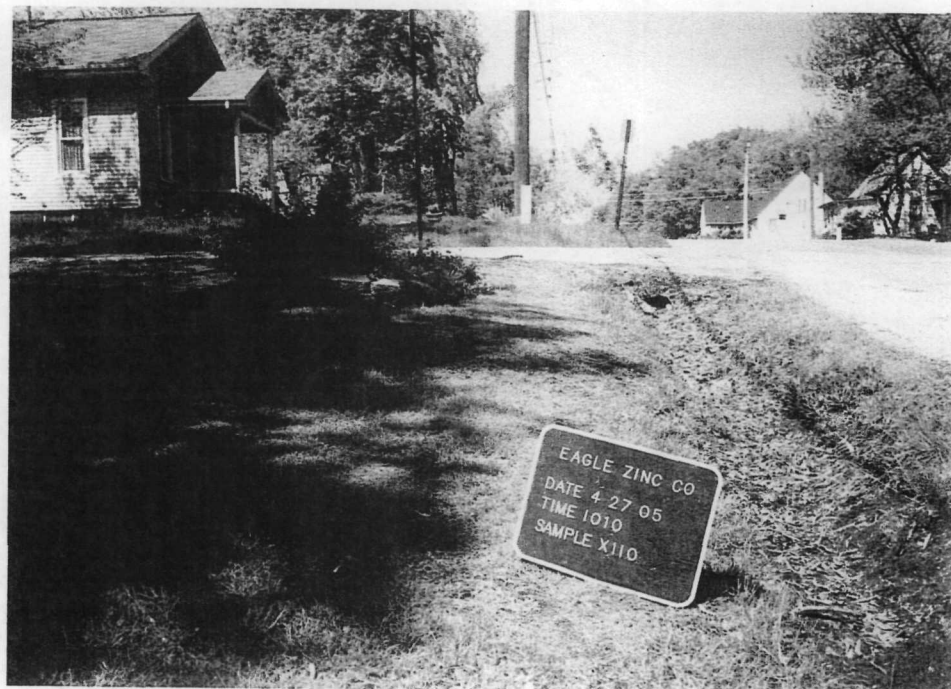
DATE: 4/27/05
TIME: 10:10
PHOTOGRAPH TAKEN BY: R. CASPER
COMMENTS: Picture taken toward: West.
Photo Number 48.
Sample X110. The sample consisted of gravel, black fill material, cinders and metal pieces.

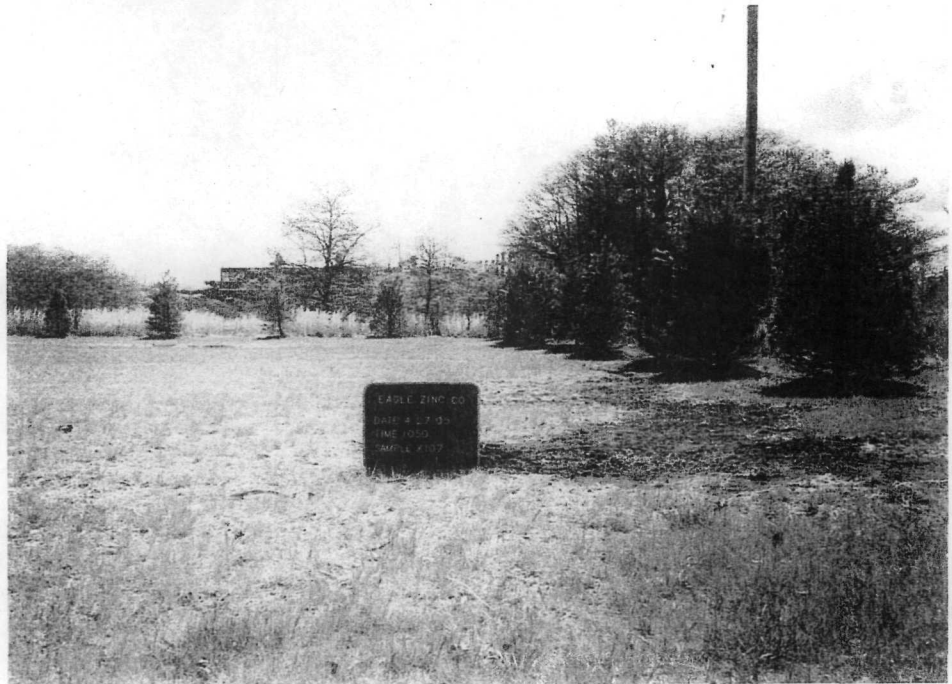
DATE: 4/27/05	SITE ILD#: 980606941	COUNTY: Montgomery
TIME: 10:50	SITE NAME: Eagle Zinc Co.	
PHOTOGRAPH TAKEN BY: R. Casper		
COMMENTS: Picture taken toward: East.		
Photo Number 49.		
Sample X107 was collected from a field west of the site near a residential area.

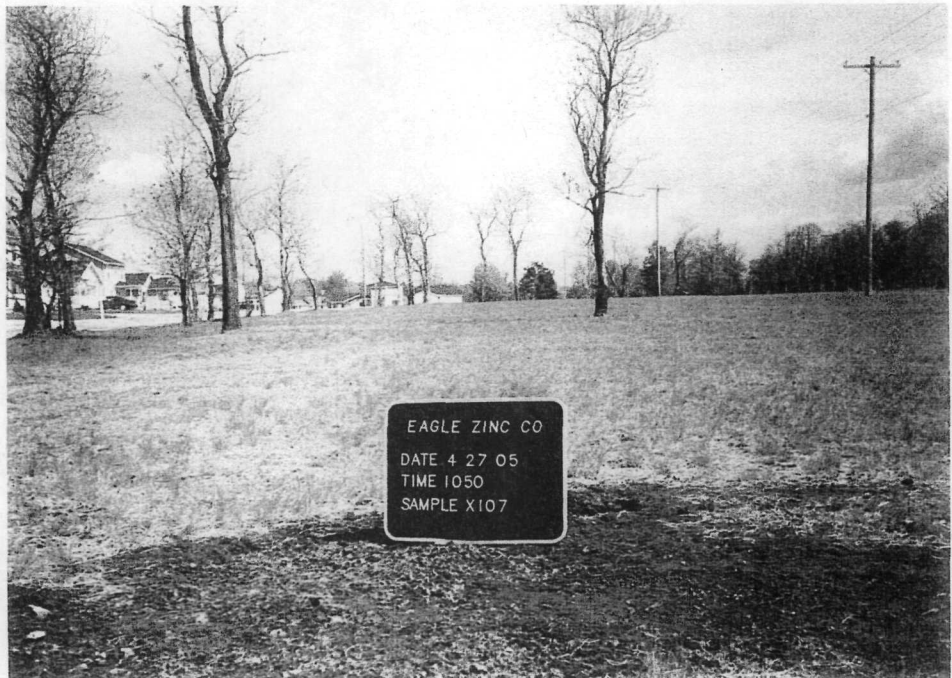
DATE: 4/27/05
TIME: 10:50
PHOTOGRAPH TAKEN BY: R. CASPER
COMMENTS: Picture taken toward: North.
Photo Number 50.
Sample X107. The sample consisted of a slag material over clay, collected at depth of 0 to 1 inch.

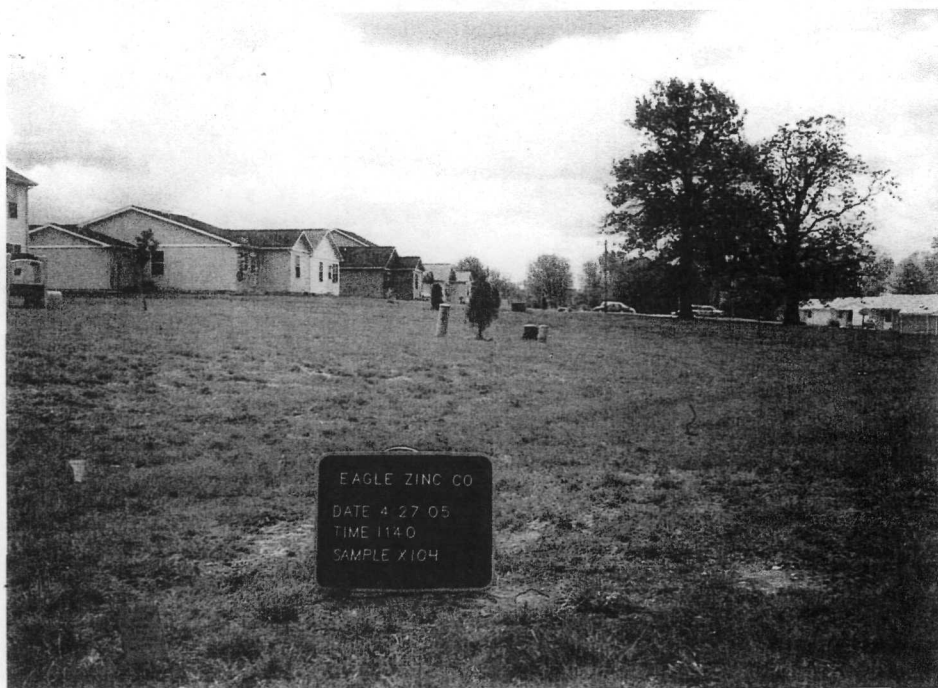
DATE: 4/27/05	SITE IL# #: 980606941	COUNTY: Montgomery
TIME: 11:40	SITE NAME: Eagle Zinc Co.	
PHOTOGRAPH TAKEN BY: R. Casper		
COMMENTS: Picture taken toward: South.		
Photo Number 51.		
Sample X104 was collected from a residential yard northwest of the site.

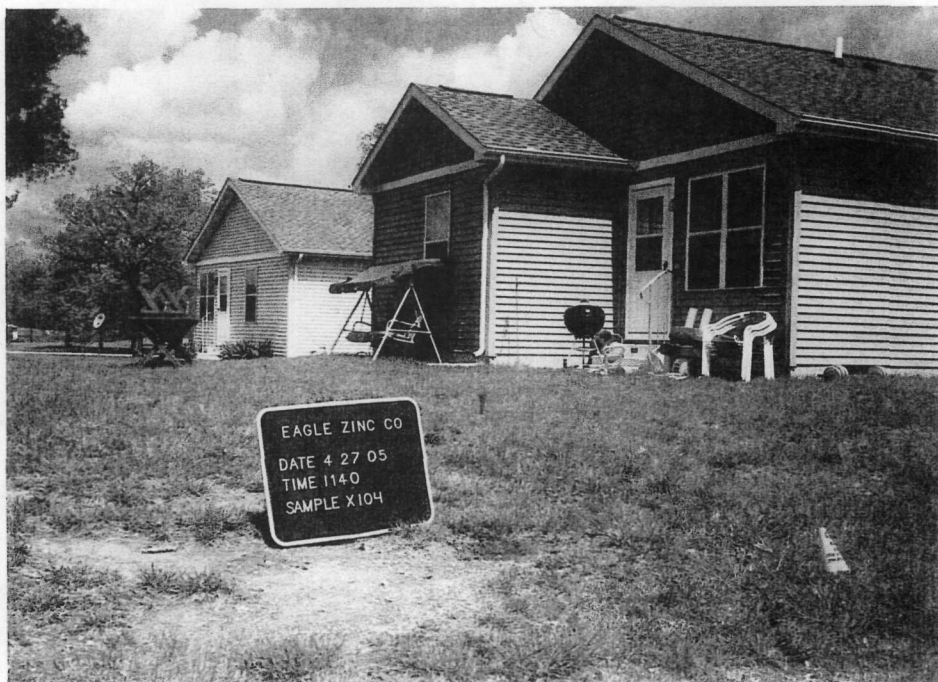
DATE: 4/27/05
TIME: 11:40
PHOTOGRAPH TAKEN BY: R. CASPER
COMMENTS: Picture taken toward: North.
Photo Number 52.
Sample X104. The sample consisted of a brown-black clay, collected at a depth of 0 to 1 inch.

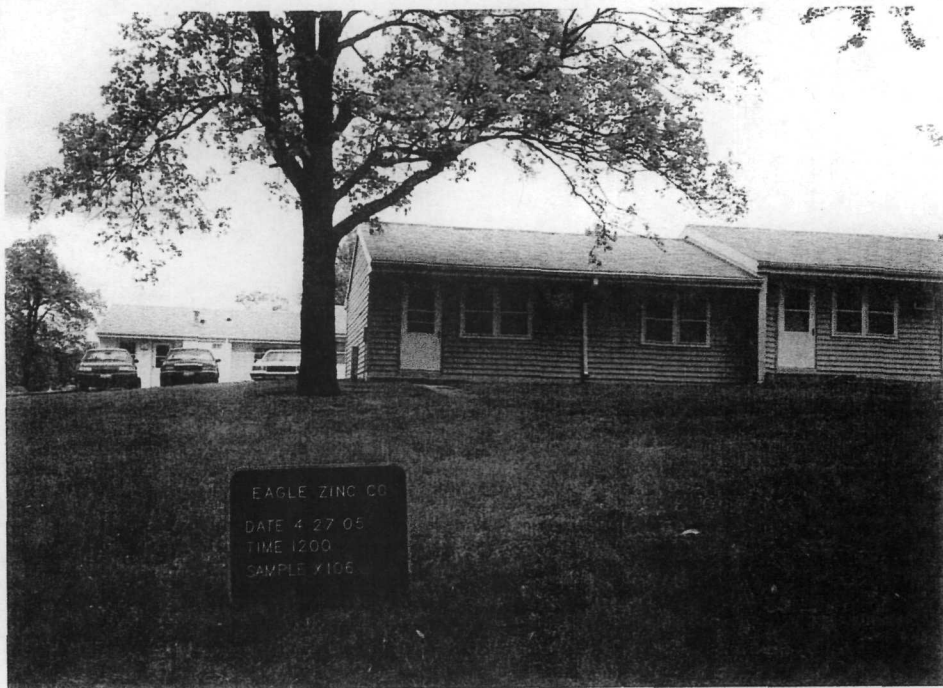
COMMENTS: Picture taken toward: North.		
Photo Number 53.		
Sample X106 was		
collected from a		
public housing project northwest of the site.

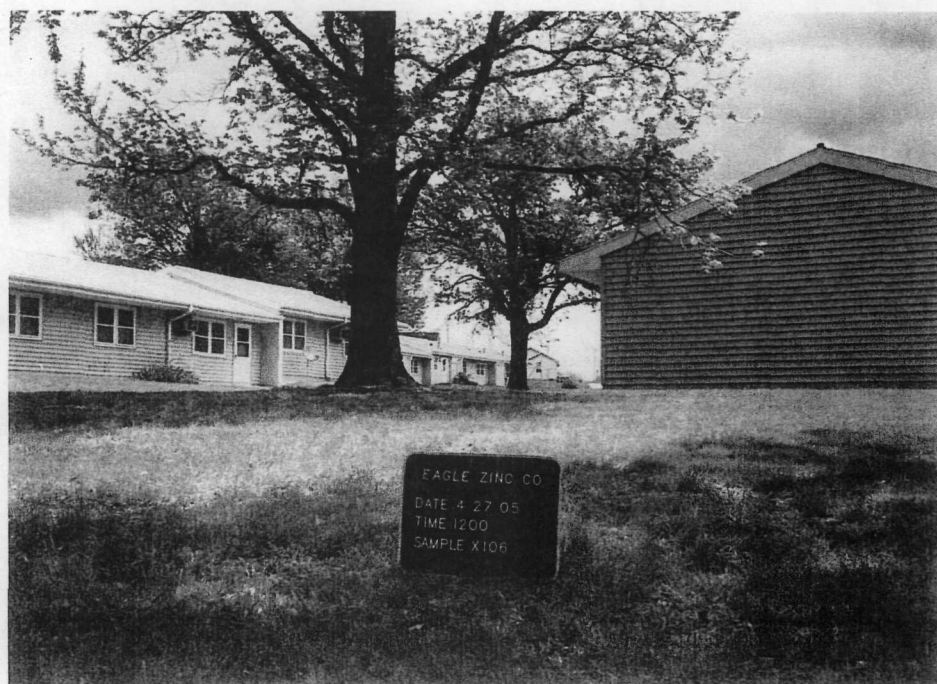
DATE: 4/27/05
TIME: 12:00
PHOTOGRAPH TAKEN BY: R. CASPER
COMMENTS: Picture taken toward: East.
Photo Number 54.
Sample X106. The
sample consisted
of a brown-black
clay loam collected
at a depth of 0
to 2 inches.

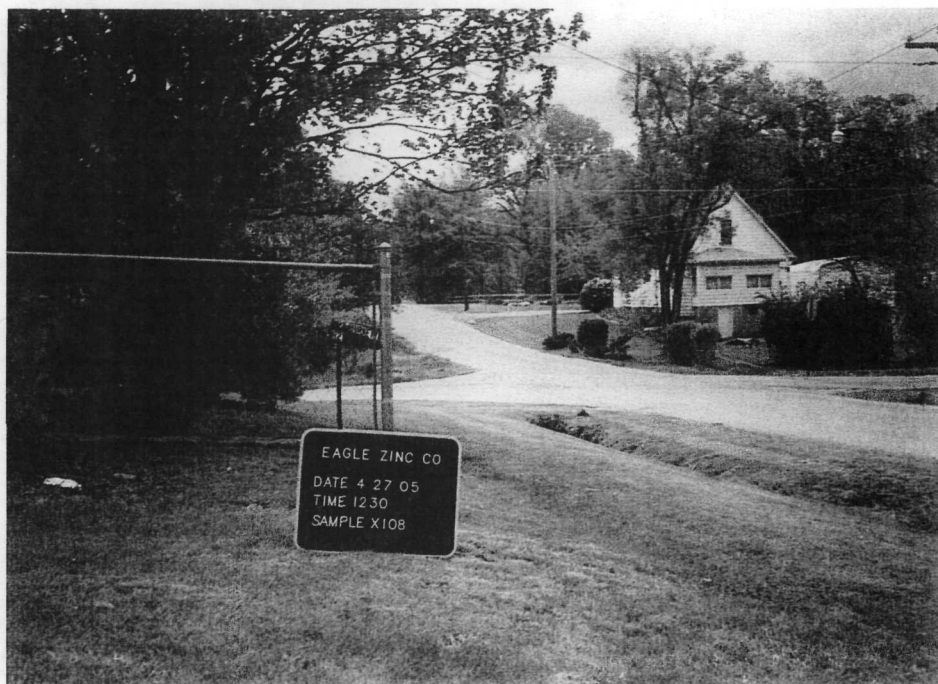
DATE: 4/27/05	SITE ILID#: 980606941	COUNTY: Montgomery
TIME: 12:30	SITE NAME: Eagle Zinc Co.	
PHOTOGRAPH TAKEN BY: R. Casper		
COMMENTS: Picture taken toward: East.		
Photo Number 55.		
Sample X108 was		
collected from a		
residential yard		
west of the site.

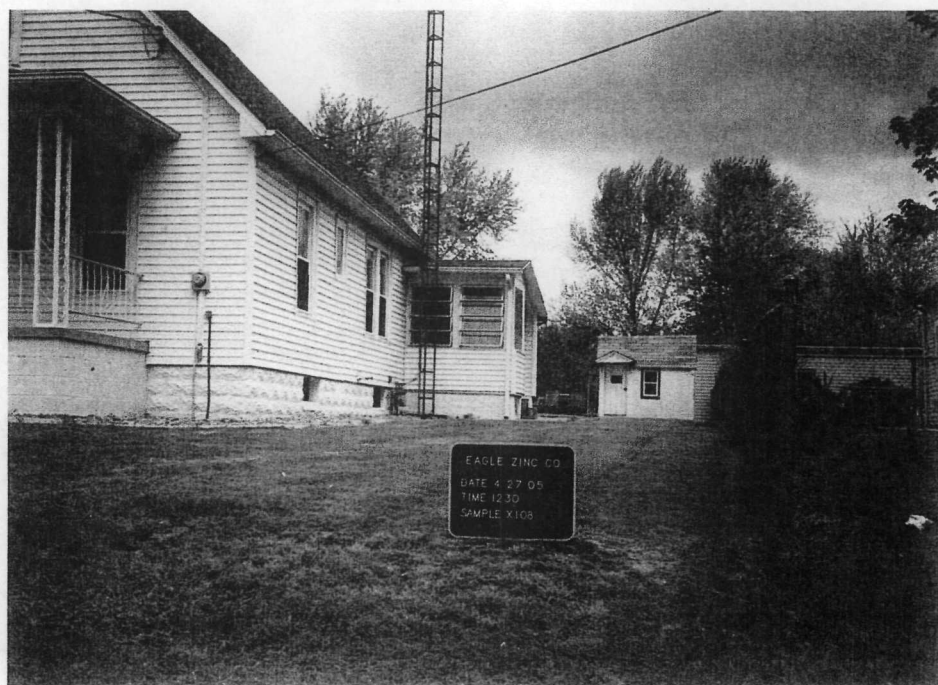
DATE: 4/27/05
TIME: 12:30
PHOTOGRAPH TAKEN BY: R. CASPER
COMMENTS: Picture taken toward: North.
Photo Number 56.
Sample X108. The
sample consisted
of a light brown
clay loam collected
at a depth of 0
2 inches.

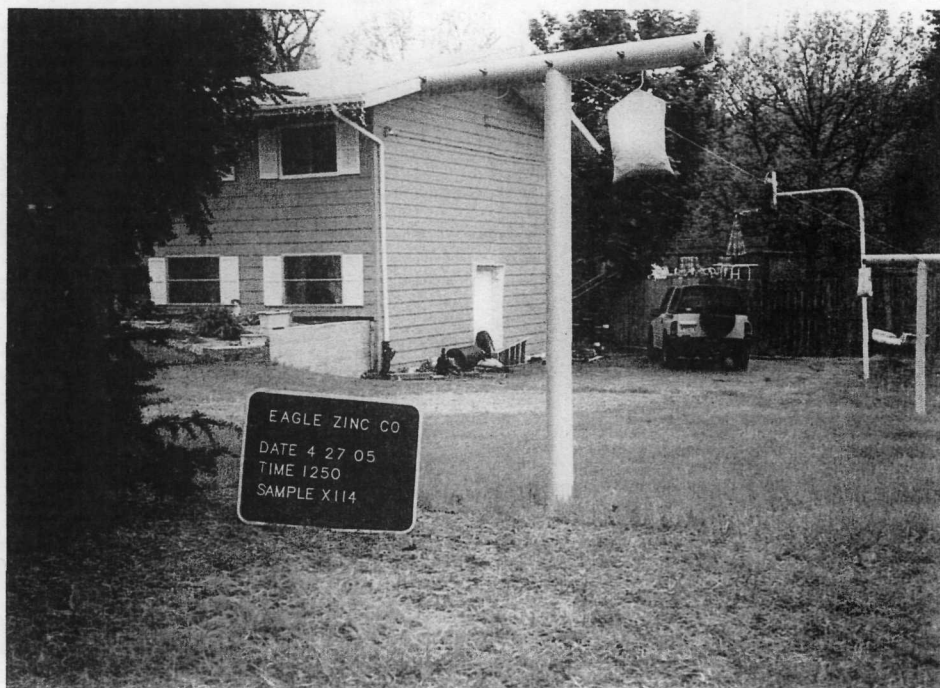
DATE: 4/27/05	SITE ILD#: 980606941	COUNTY: Montgomery
TIME: 12:50	SITE NAME: Eagle Zinc Co.	
PHOTOGRAPH TAKEN BY: R. Casper		
COMMENTS: Picture taken toward: West.		
Photo Number 57.		
Sample X114 was collected from a residential yard northwest of the site.

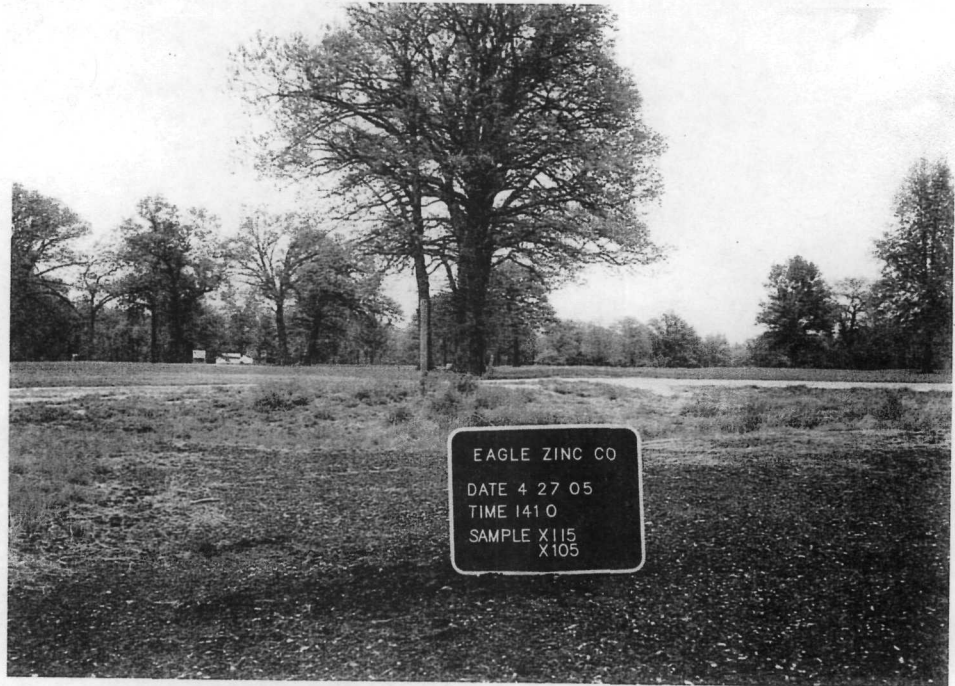
DATE: 4/27/05
TIME: 14:10
PHOTOGRAPH TAKEN BY: R. CASPER
COMMENTS: Picture taken toward: East.
Photo Number 60.
Samples X115/X105.
Duplicate samples consisting of cinders, slag material and black fines.
